# CCA/TAP Communication And TS4 MLPE Troubleshooting Guide

A comprehensive guide for InstaGroup technicians to diagnose and resolve communication issues between the Tigo TS4s, the Cloud Connect Advanced (CCA) and Tigo Access Point (TAP) components in solar monitoring systems.

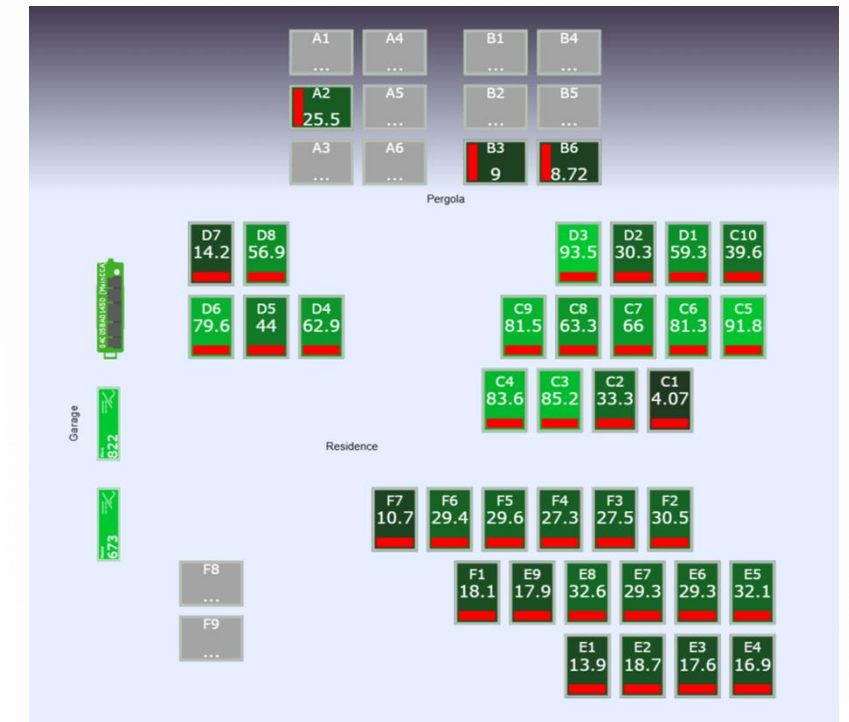
- Grey modules on EI App or Portal
- Missing TS4s on EI Ap or Portal
- EI App shows low RSSI values (<80)
- Low production from inverter

- Excessive distance between TAP and TS4 units
- Roof obstructions blocking RF signal
- Incorrect TAP placement (wrong tilt/azimuth or behind structures)
- RF interference from nearby equipment

Grey modules = no communication

1. Review TAP placement and ensure it's central to module layout.
2. Relocate TAP to improve line-of-sight with TS4s.
3. Add an additional TAP for large or multi-level arrays.
4. Verify that nearby equipment is not causing RF interference.

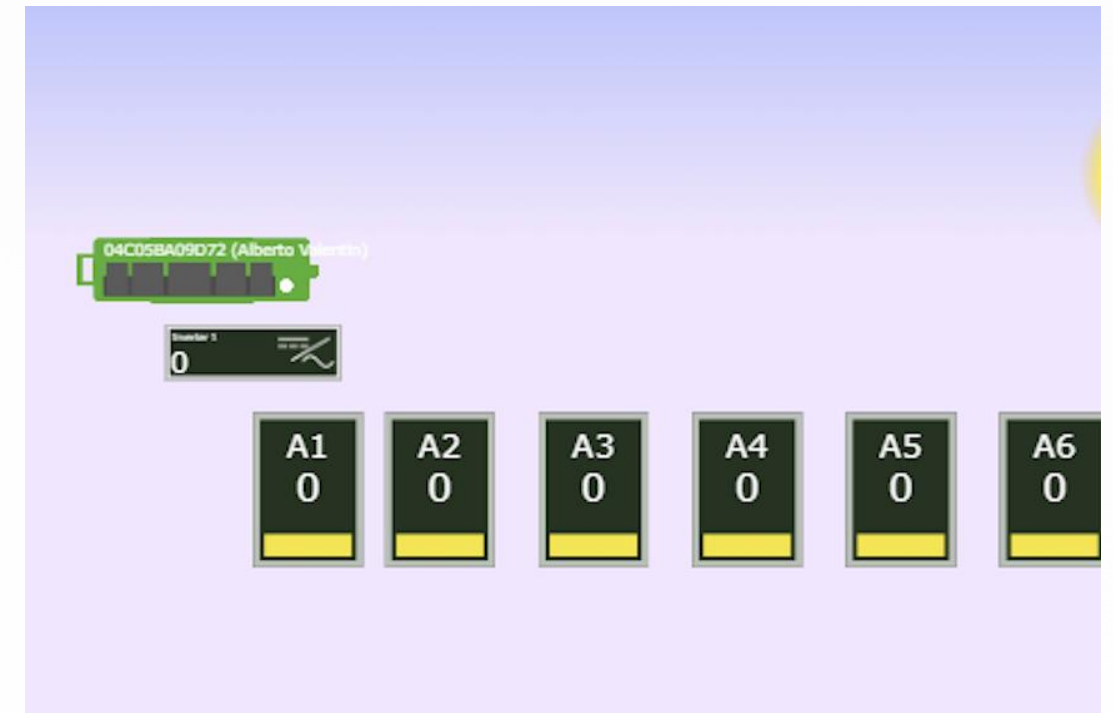
- Grey modules on EI App or Portal
- Missing TS4s on EI App or Portal
- Missing TAPs on EI App or Portal
- Low production from inverter

- RS485 wiring misconfiguration or loose connections
- Missing or incorrect terminator on the last TAP
- TAP powered off or damaged

Black modules = no TAP detection of TS4s

1. Check RS485 wire color match at TAP and CCA.
2. Perform a pull test on TAP terminals.
3. Ensure terminator is installed on the final TAP.
4. Confirm TAP has power (check LED, if available).
5. If still undetected, swap TAP with known working unit.

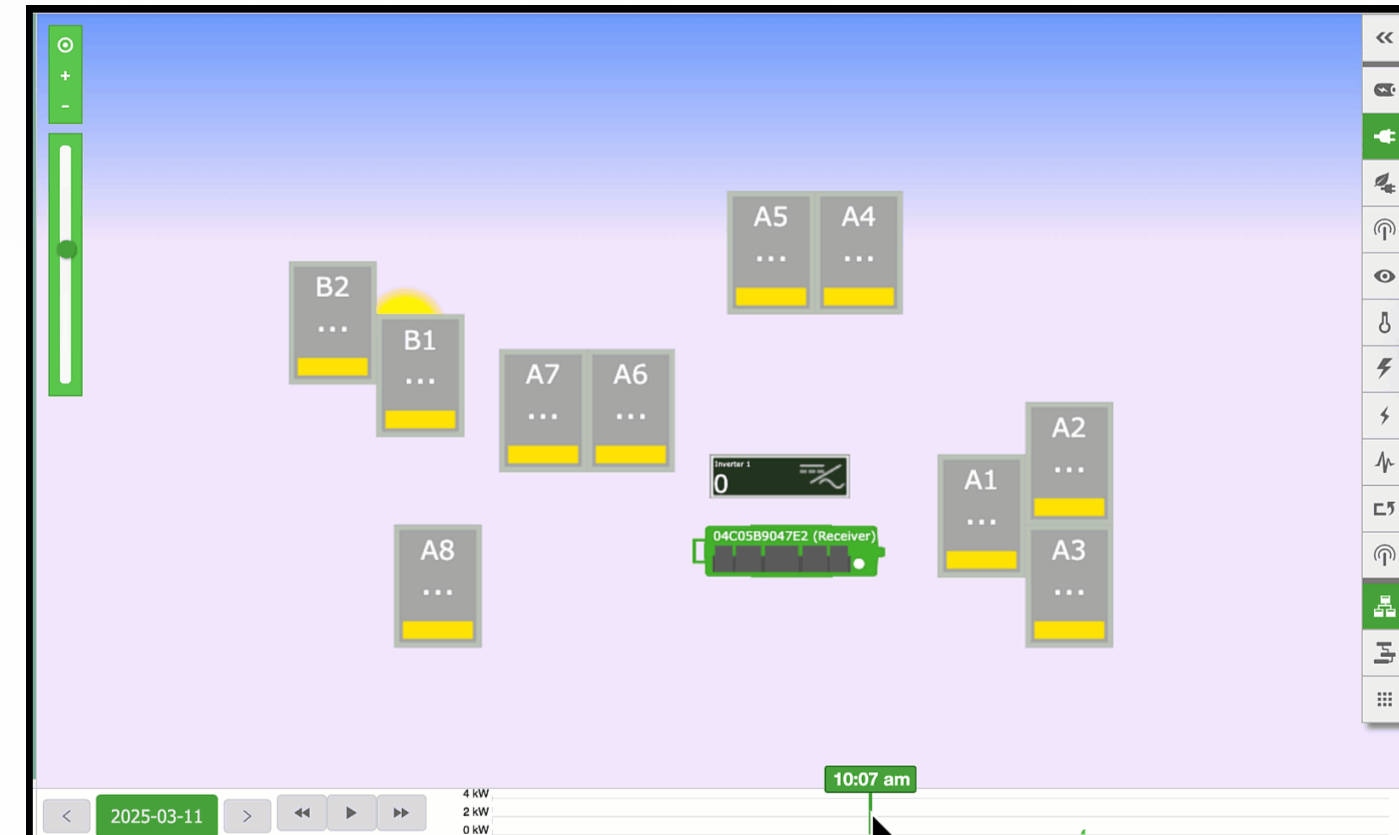
- System goes online/offline randomly, or some modules stop reporting then come back.

- RS485 wiring misconfiguration or loose connections
- Missing or incorrect terminator on the last TAP
- TAP powered off or damaged

Sliding the timer reveals a time of day when there was brief production

1. Check RS485 wire color match at TAP and CCA.
2. Perform a pull test on TAP terminals.
3. Ensure terminator is installed on the final TAP.
4. Confirm TAP has power (check LED, if available).
5. If still undetected, swap TAP with known working unit.

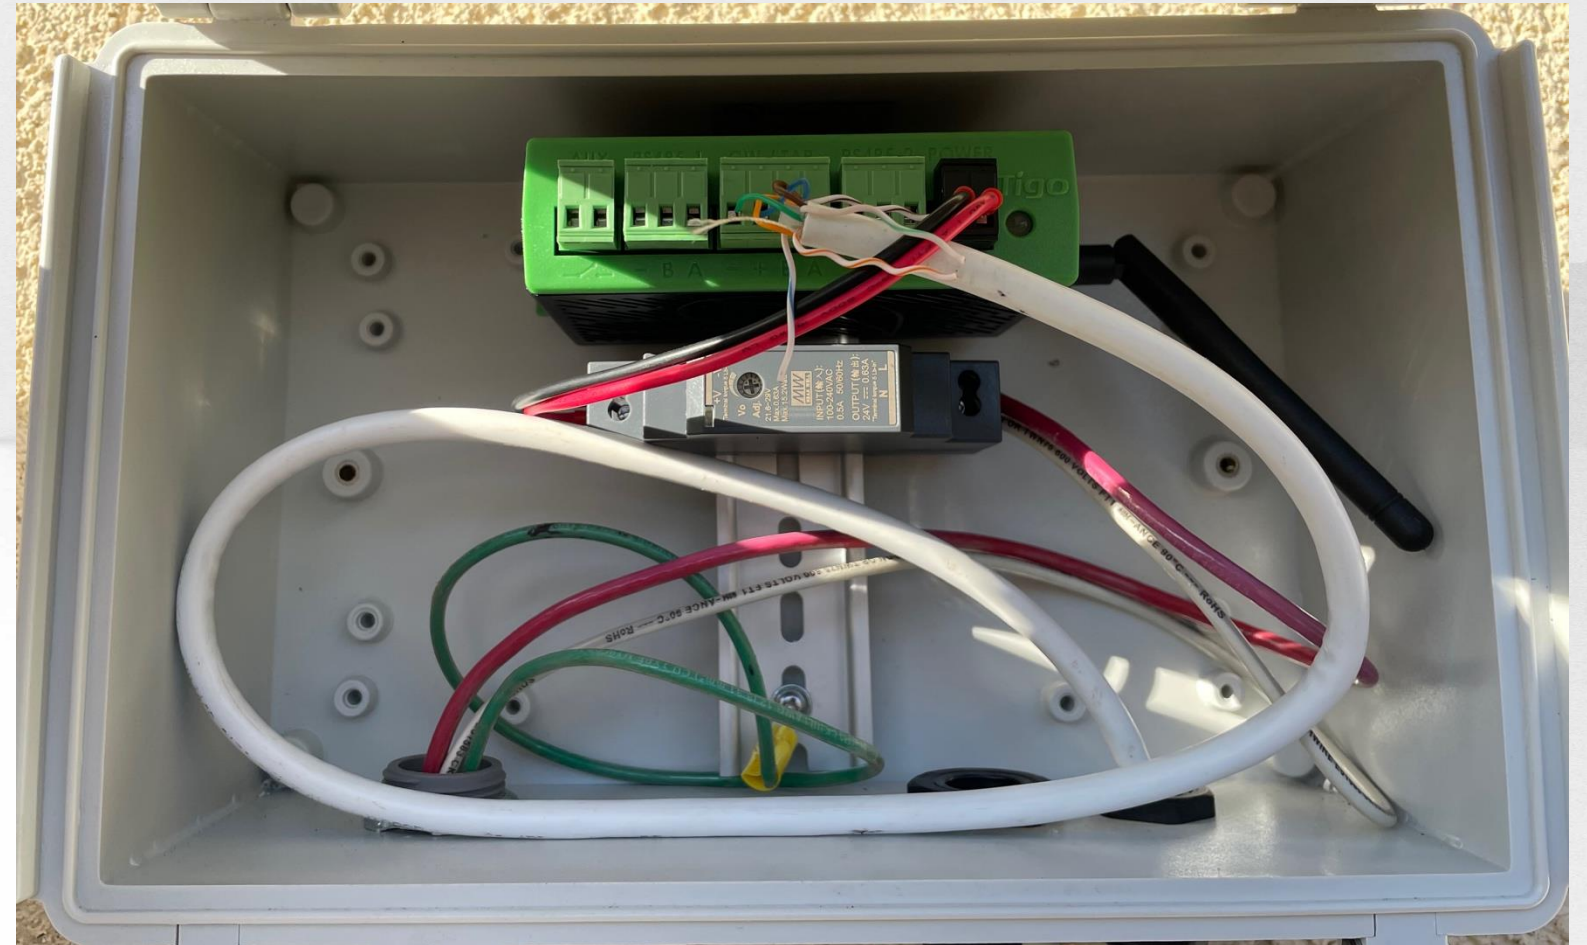
- CCA LEDs are dark
- No PV production

- CCA power supply is wrong voltage (24V)
- AC power to the CCA is not on

Troubleshooting revealed all CCA to TAPs wiring was correct. 24VDC power supply verified. The AC breaker that supplied 120V to the power supply was not turned on.

1. Verify 24V power supply
2. Verify AC breaker to CCA is turned on

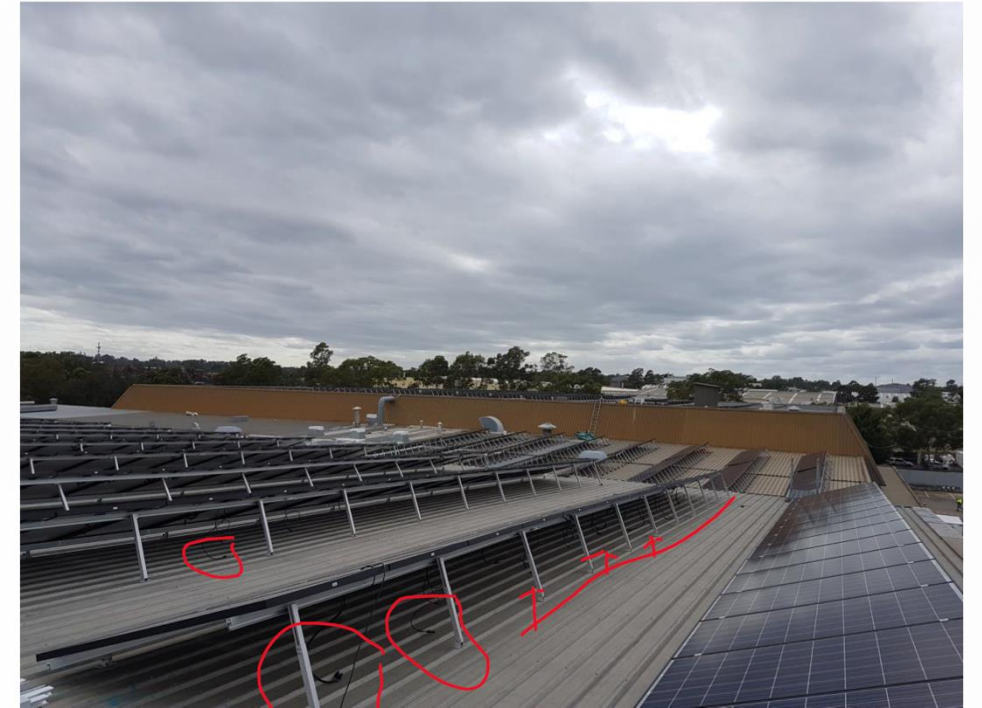
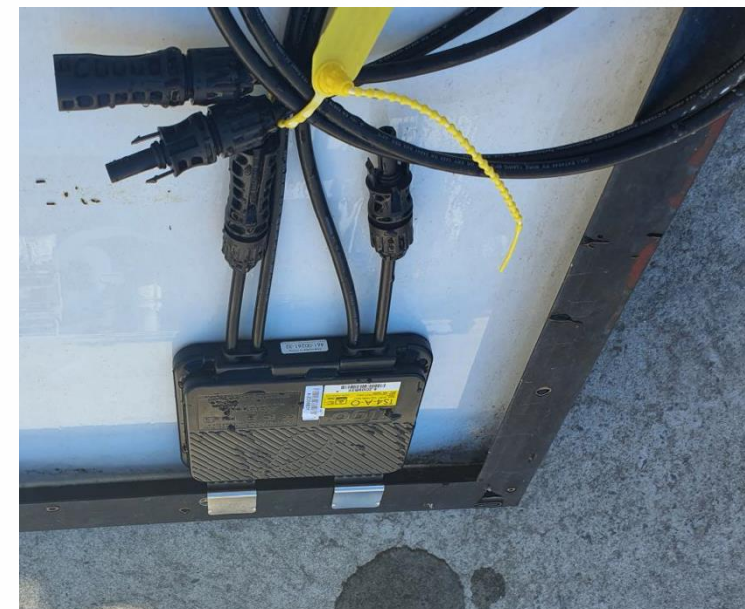
# 1. Water ingress

- TS4s are stored outside with the cables exposed to rain or moisture
- TS4s are mounted to the module with the glad seals facing upward

1. Replace the TS4
2. Future installs must adhere to handling requirements

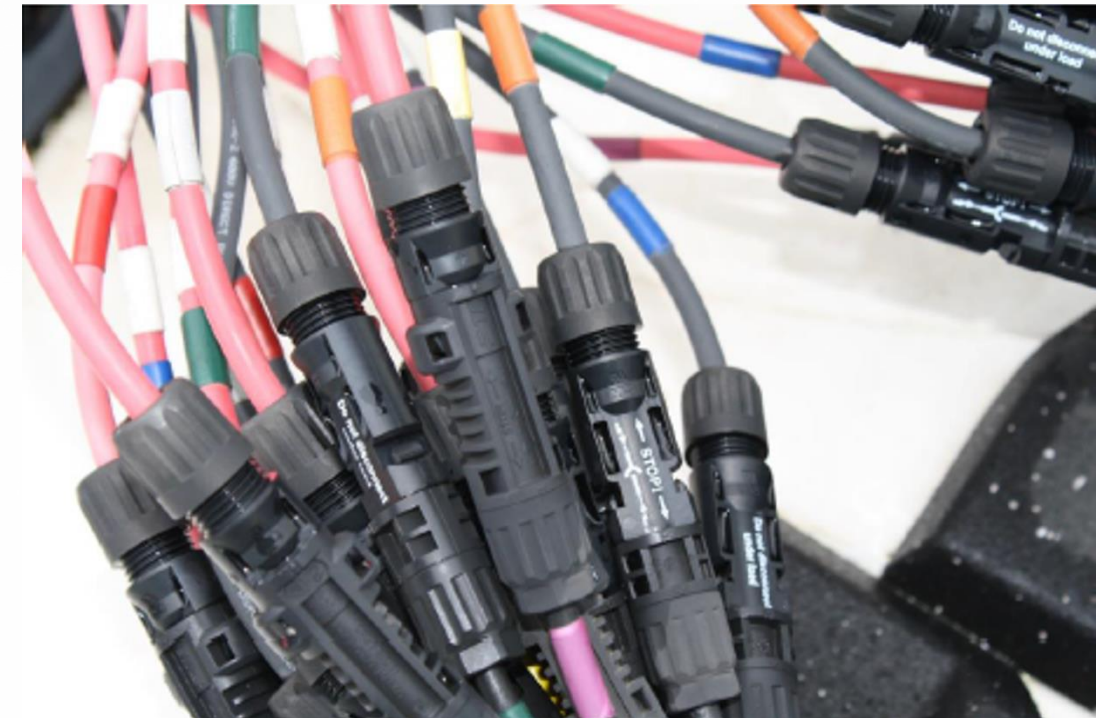
- Bad crimps
- Improper connector torque
- Connectors not completed as per manufacturer's directions
- Imposter "compatible" MC4 connectors do not mate properly and can cause connector hotspots

Cap screws not tightened enough

1. Replace the TS4
2. Future installs must adhere to proper connector requirements

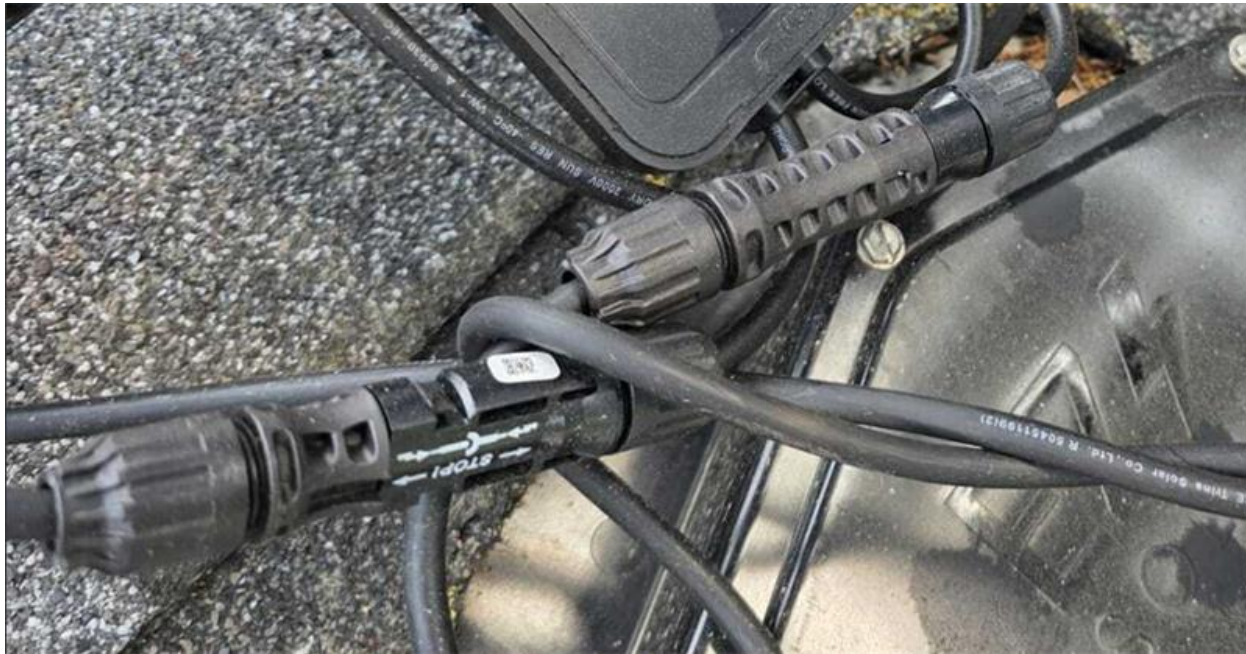
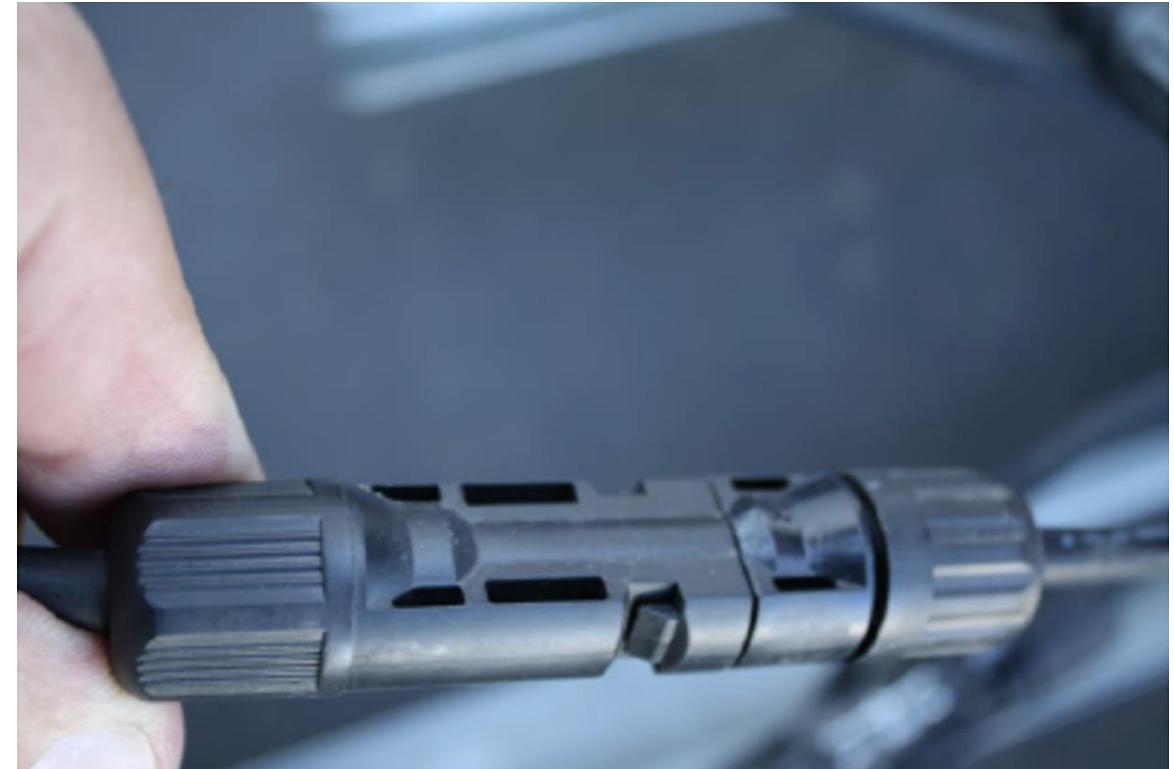
Different connector types

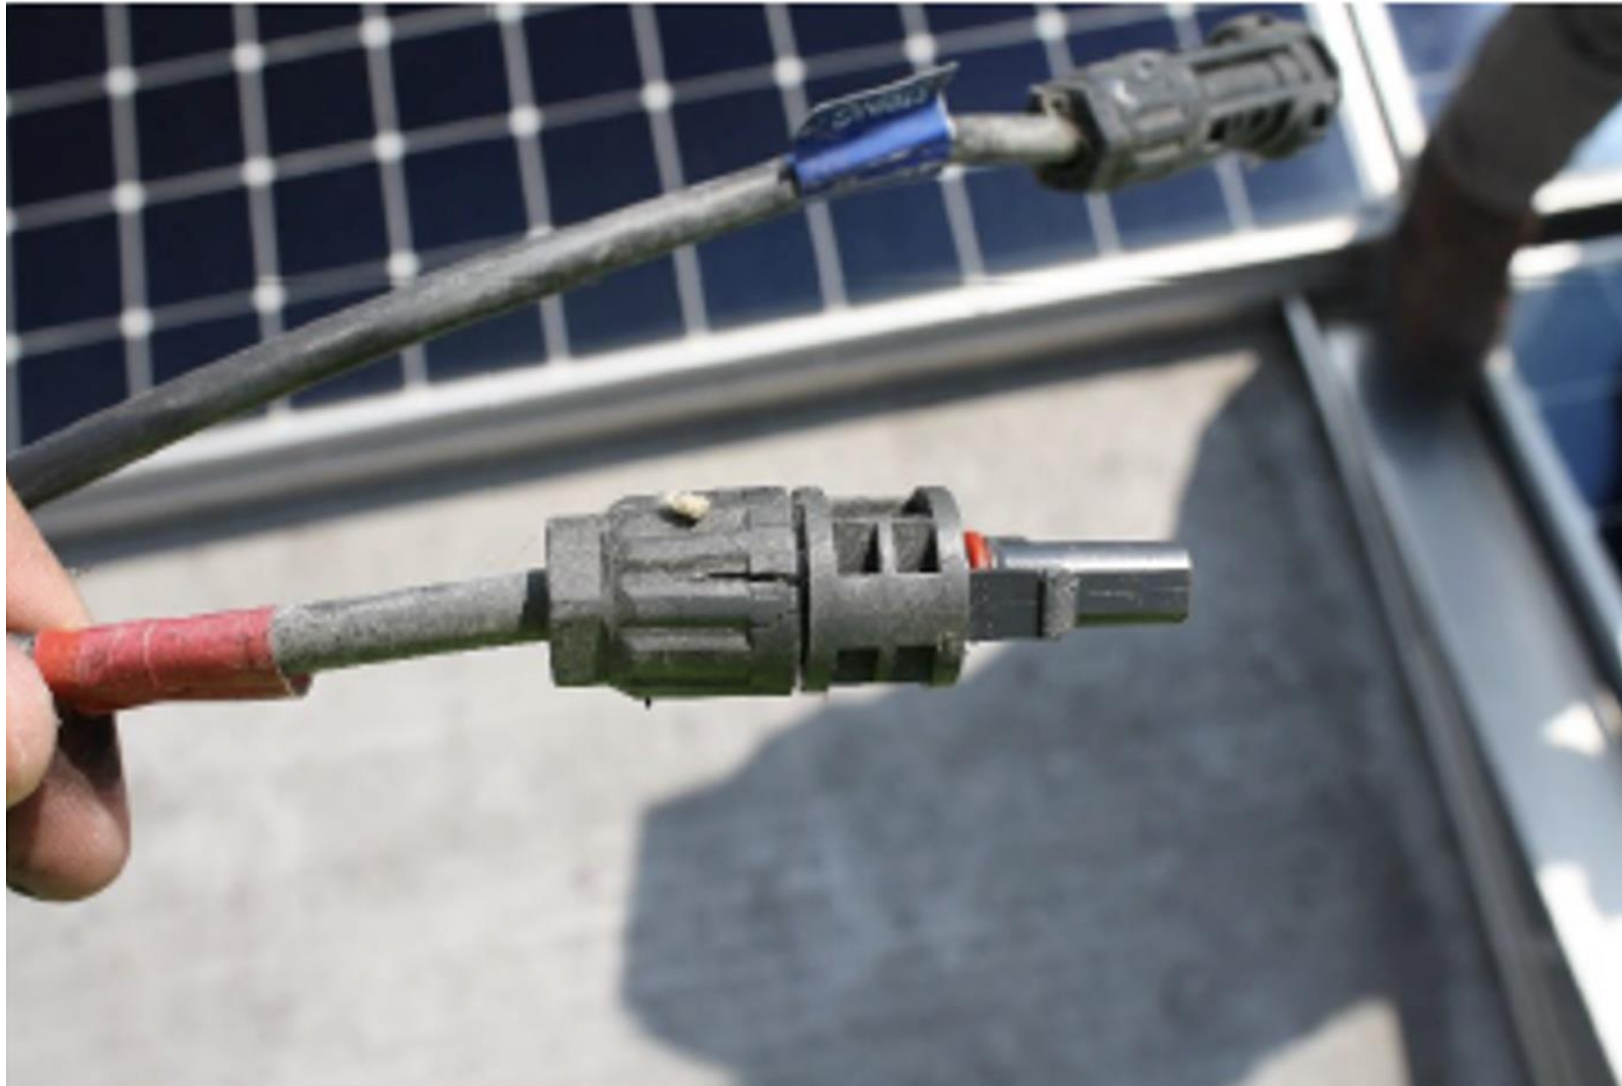
Overtorqued

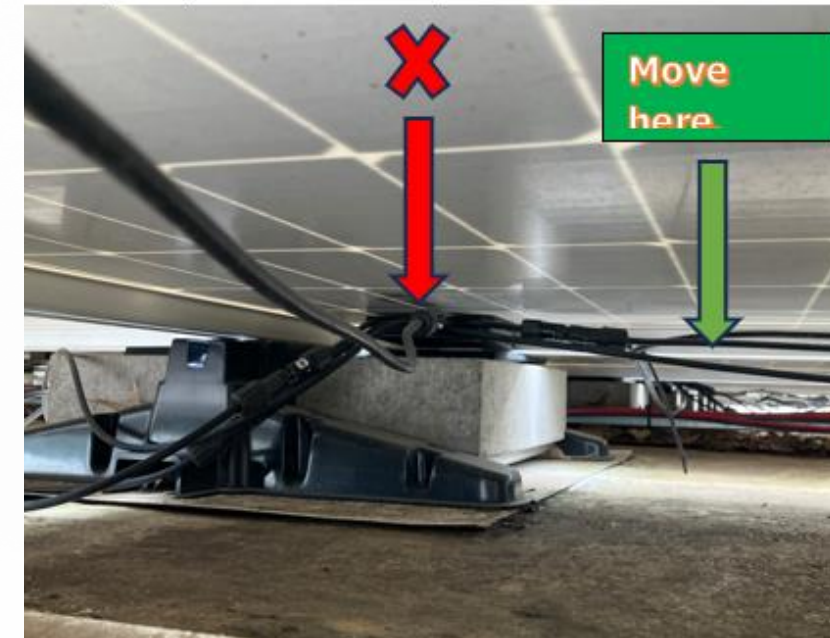
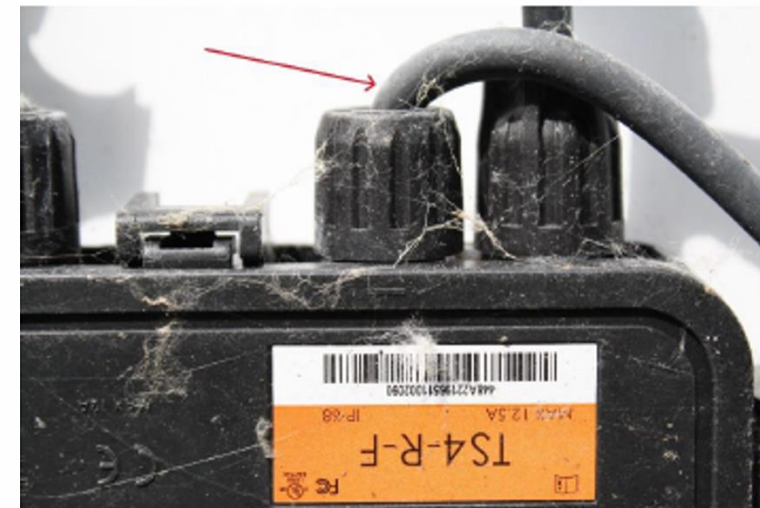
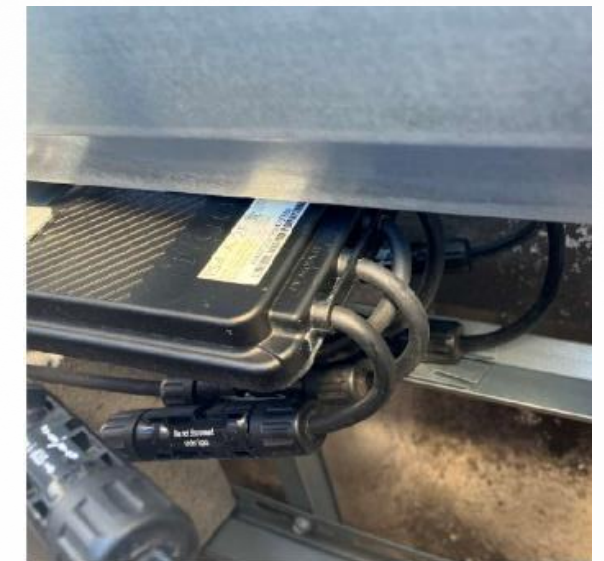
- Lack of airflow around TS4 (minimum 1.27 cm)
- TS4 mounted on module made it too close to backsheet
- TS4 mounted too close to ballast, rails, etc.

1. Replace the TS4
2. If TS4 is too close to the module backsheet, flip the unit and remount with the label facing towards the module.
3. Do not have a tight bend radius on TS4 connectors
4. Future installs must adhere to proper mounting requirements

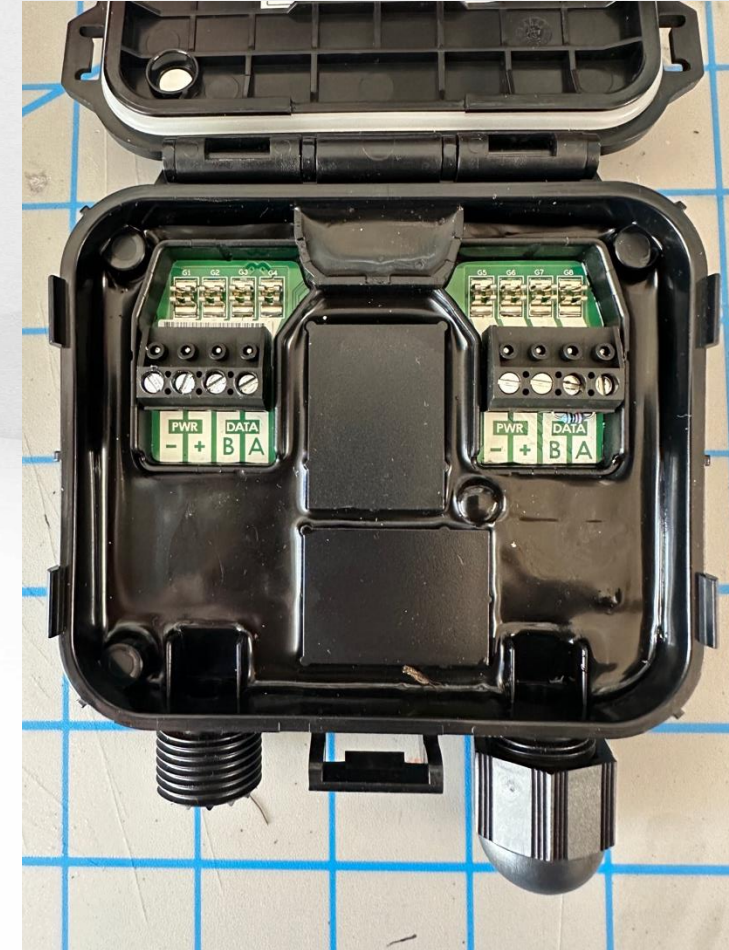
- Check for water infiltration inside TAP housing
- Verify cover is properly sealed
- Ensure gland seals on bottom are correctly oriented (not pointing upward)

Moisture is a common cause of intermittent communication failures and component damage.

⊗ Warning: Improperly sealed TAP enclosures can lead to water damage and system failure.
