# CCA/TAP Communication And TS4 MLPE Troubleshooting Guide

A comprehensive guide for InstaGroup technicians to diagnose and resolve communication issues between the Tigo TS4s, the Cloud Connect Advanced (CCA) and Tigo Access Point (TAP) components in solar monitoring systems.

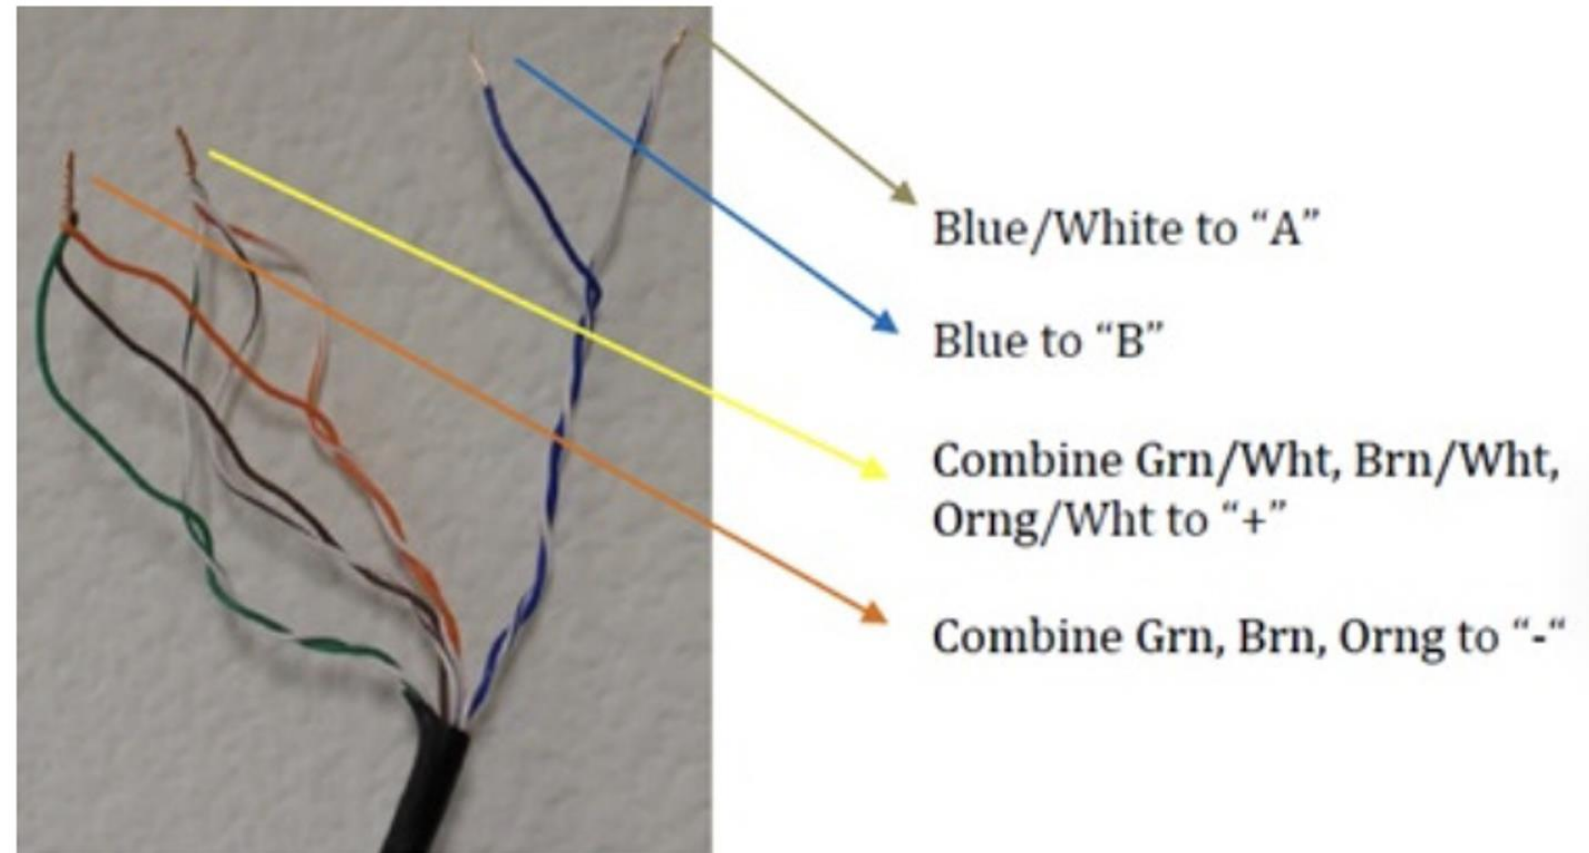
- Ensure wiring colors are the same from left to right on all TAPs and the CCA
- If using CAT5/6 you must use the wire pairing in this image
- If not, there is not enough power to adequately reach the furthest TAPS

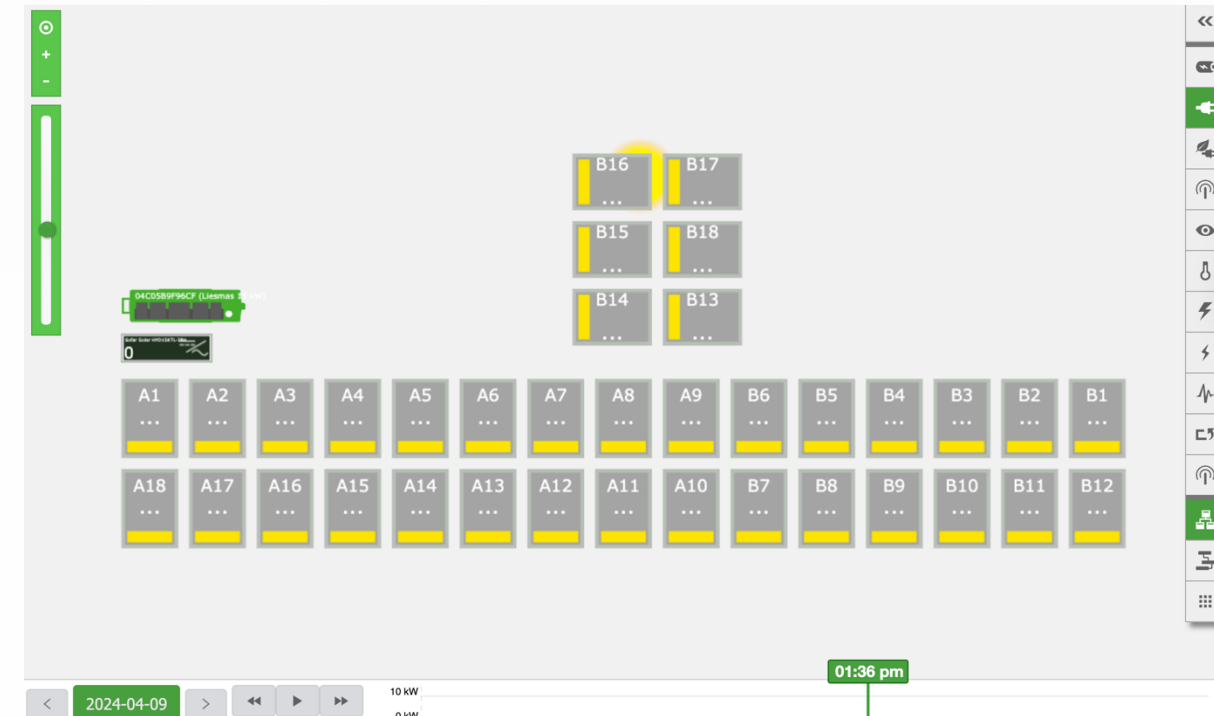
- Portal shows inverter data, but no individual module readings appear.

- System not yet commissioned in EI App
- TAP not communicating with TS4s
- TS4s are unpaired or incorrectly installed
- CCA firmware outdated or misconfigured

1. Ensure system is fully commissioned using the EI App.
2. Confirm TAP is visible and communicating.
3. Check TS4 serial numbers for correctness and pairing.
4. Reboot the CCA.
5. Update firmware via EI App if needed.

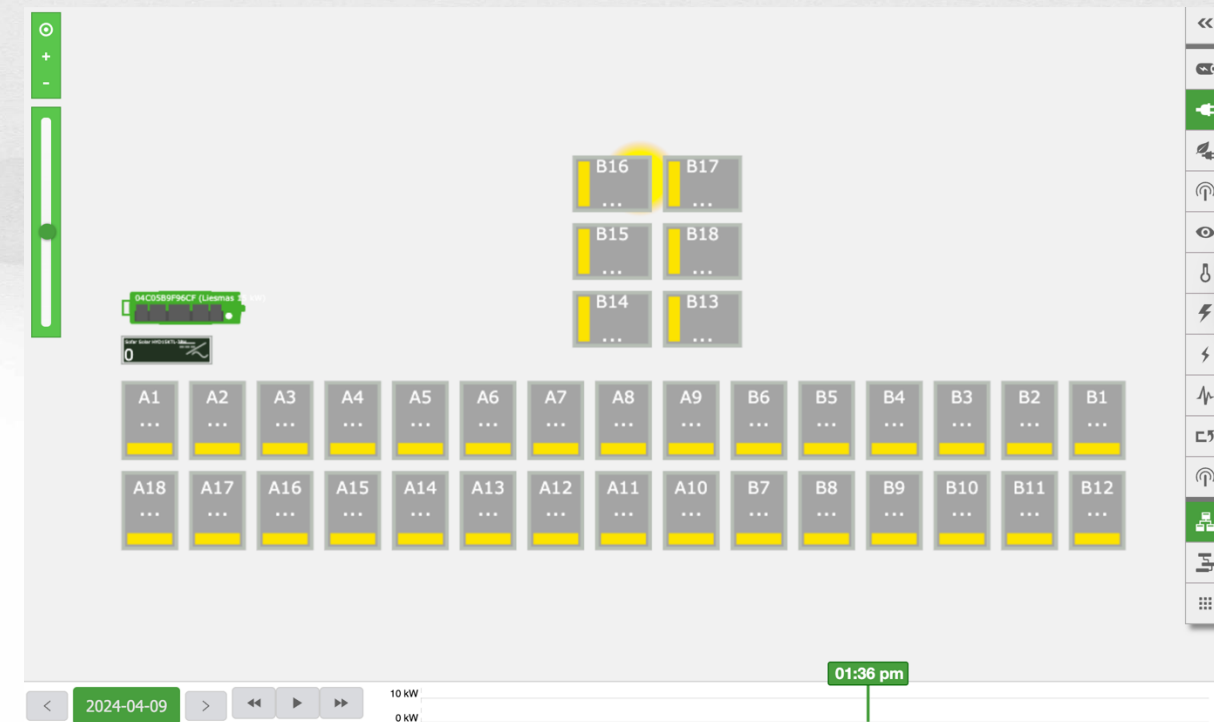
- System data appears outdated, frozen, or not synced with real-time performance.

- CCA lost internet connection (Wi-Fi or Ethernet)
- DNS/firewall blocks communication to Tigo servers
- CCA rebooted improperly or frozen
- Portal-side data sync delay

1. Check CCA internet connectivity (router, IP address, signal strength).
2. Reboot the CCA (power cycle).
3. Confirm port 443 is open for outbound traffic.
4. Check the last upload time on the portal.
5. If unresolved, re-link CCA in the EI App.

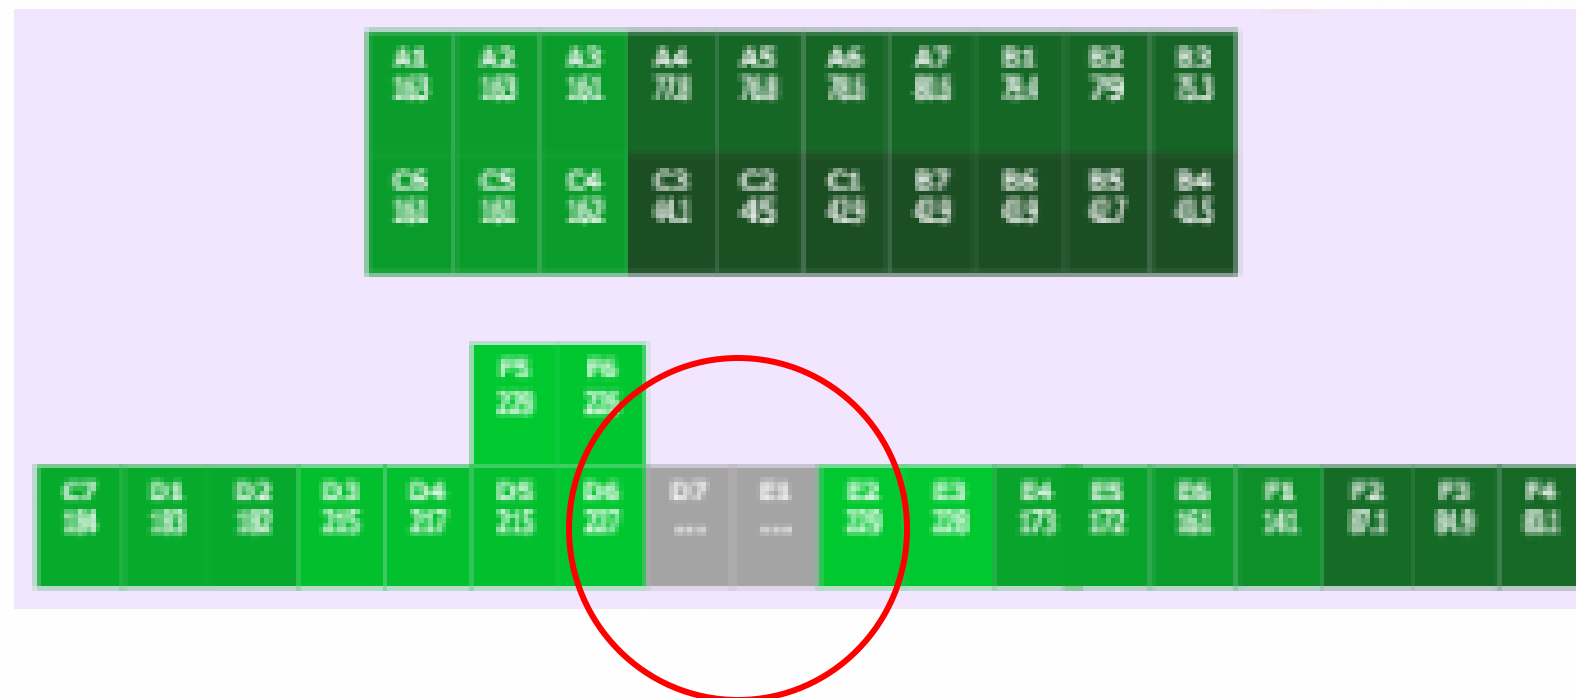
- The switch that isolates the module from the string may become faulty.
- Error message appears on EI App/Portal stating a switch failure.
- **Gray modules** could be an indicator of a switch failure.
- This fault requires an RMA replacement

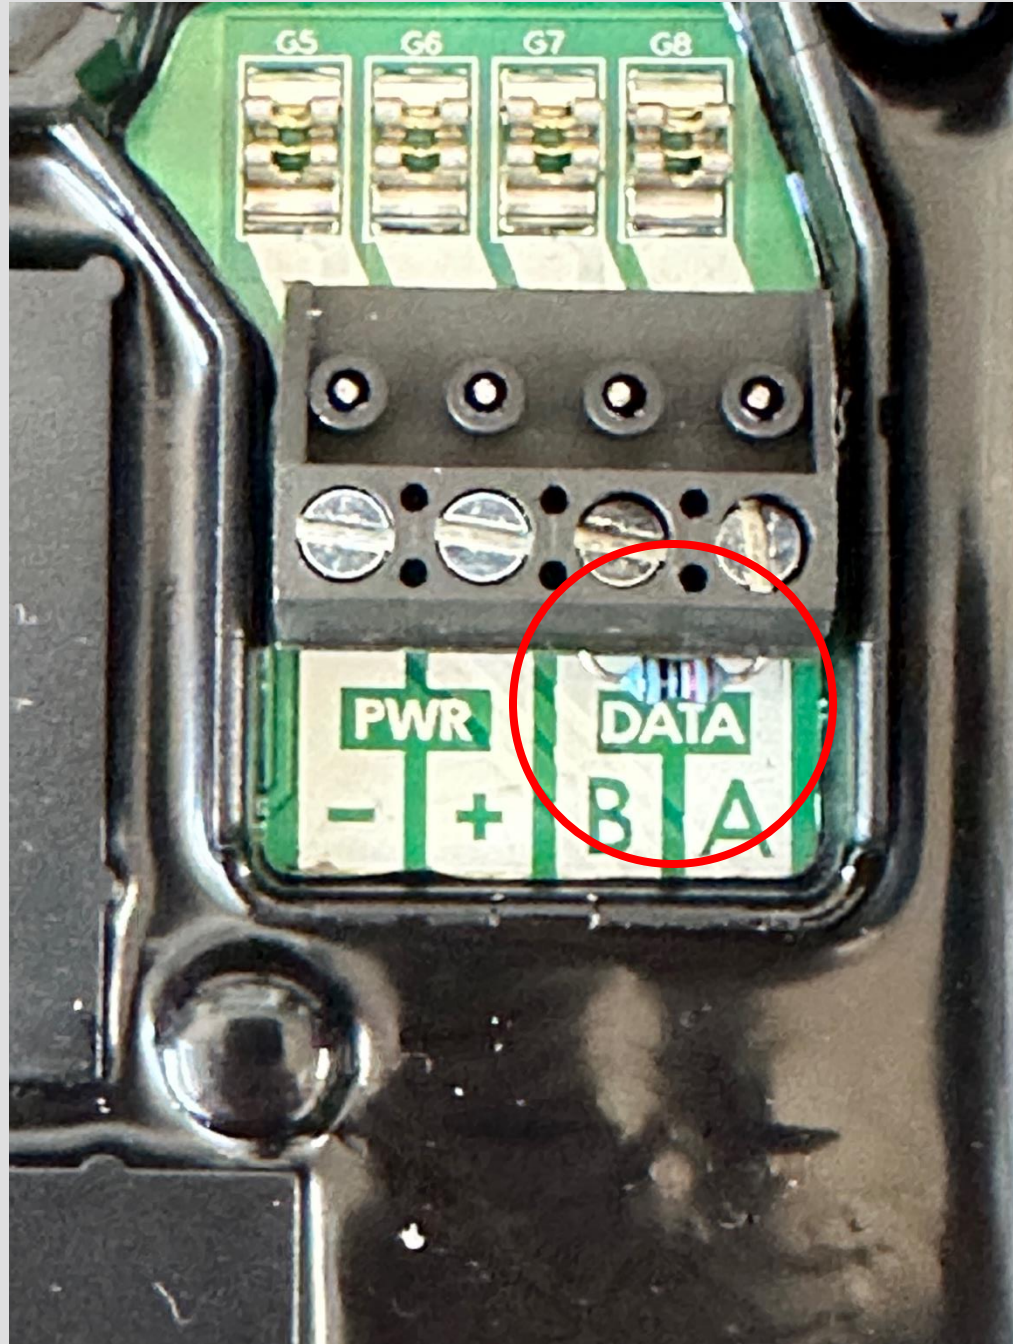
Confirm 120 Ohm terminator is installed only on the last TAP's right terminal block
